Fracture of the Alumina-bearing Couple Delta Ceramic Liner

Afshin Taheriazam, MD; Mohammad Azizbaig Mohajer, MD; Mansoour Aboulghasemian, MD; Babak Hajipour, MD

This article describes a case of a fracture of an alumina-bearing couple delta ceramic liner without trauma history that was treated with ceramic-on-polyethylene revision total hip arthroplasty. A 57-year-old man was admitted to the hip ward because of an alumina-bearing couple delta ceramic liner fracture. He underwent hip replacement by anterior approach 18 months previously in the same center because of left hip primary osteoarthritis. He received a 54×36 -mm modular press-fit cup ceramic alumina-bearing couple delta insert. Probable causes of such fractures are manufacture production failure and edge loading based on cup inclination, but in our patient, inacceptable range of motion, failure of the locking mechanism during implantation insertion, or cracking were possible causes of fracture.

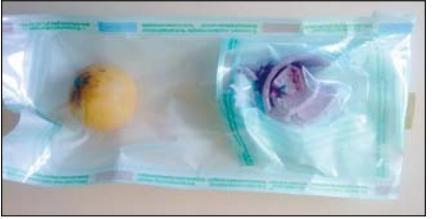
Figure: Fractured alumina-bearing couple delta ceramic liner.

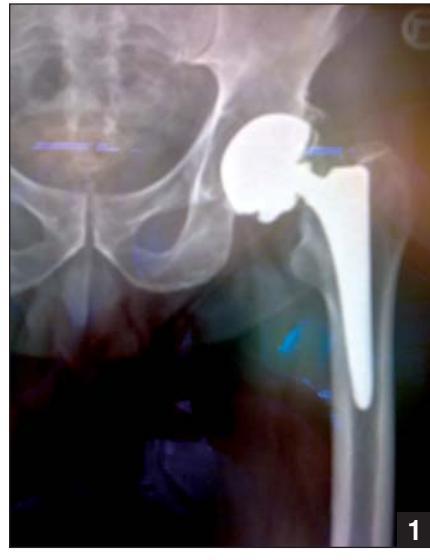
The patient had a safe postoperative period. At 18 months postoperatively, he had tenderness and a clicking sound in his left hip. On physical examination, no findings except hip tenderness during walking and at the end of his hip range of motion were found. A ceramic liner fracture was detected on radiographs. During revision surgery, the surgeon discovered that the ABC delta ceramic liner was fractured into multiple particles. The femoral and acetabular components were fixed well, and the ceramic head was intact (Figures 1, 2). Extensive sinovectomy was performed to remove multiple ceramic particles, and polyethylene and a new ceramic head were inserted. The had no postoperative tenderness or a limp.

Figure 1: Radiograph showing a failed ceramic hip arthroplasty.

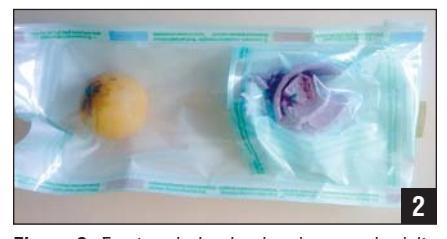
Figure 2: Fractured alumina-bearing couple delta ceramic liner.

Fracture can occur due to manufacture production failure and edge loading based on cup inclination, but in our patient, unacceptable range of motion, failure of the locking mechanism during insert implantation, or cracking during implantation was the cause.
